# **INDOOR AIR QUALITY ASSESSMENT**

**Forbush Memorial Library  
118 Main Street  
Westminster, Massachusetts**

Prepared by:  
Massachusetts Department of Public Health  
Bureau of Environmental Health  
Indoor Air Quality Program  
December 2007

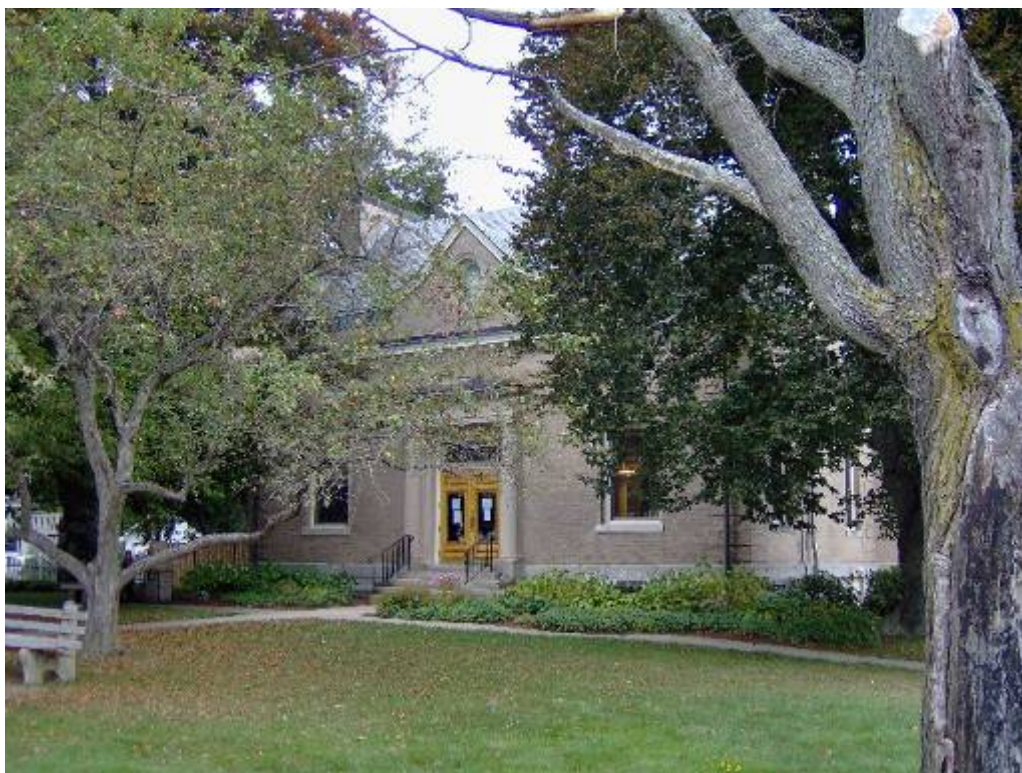
**Picture 1**

The FML was constructed in 1901 as a two-story, brown brick building (Picture 1). An addition was made to the north wall of the building in 1997 (Picture 2). During the 1997 addition construction, ventilation equipment and renovations were made to the 1901 building. Windows are openable throughout the building.

**Original FML Constructed In 1901**

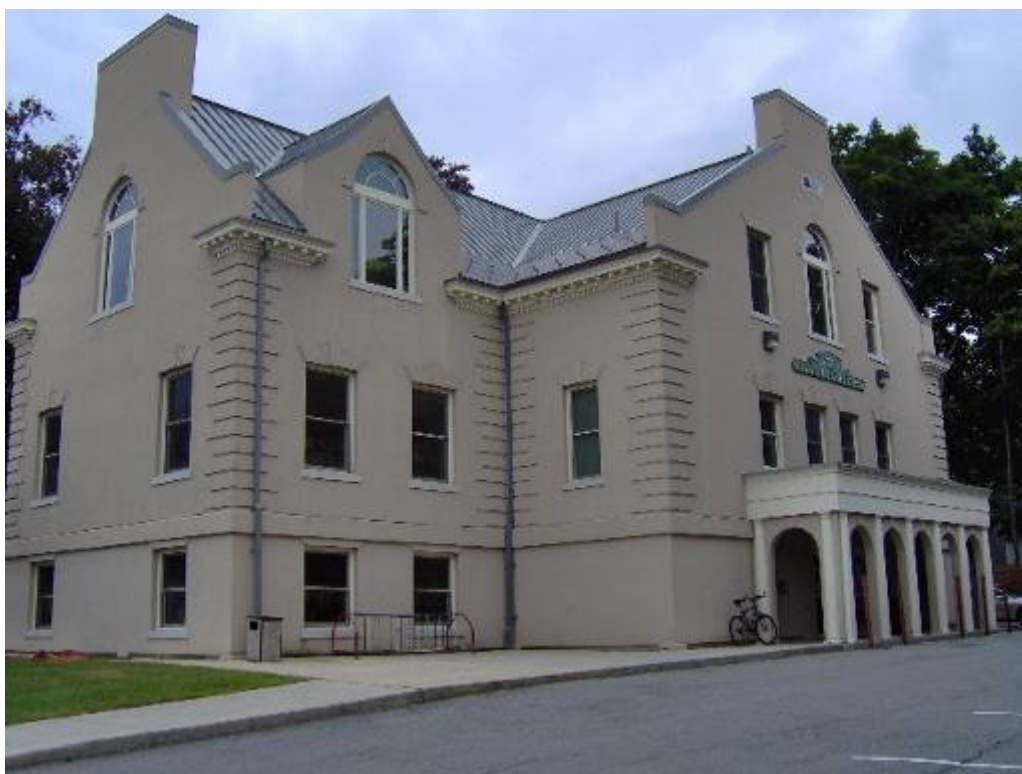
**Picture 2**

**New FML Wing Constructed In 1997**

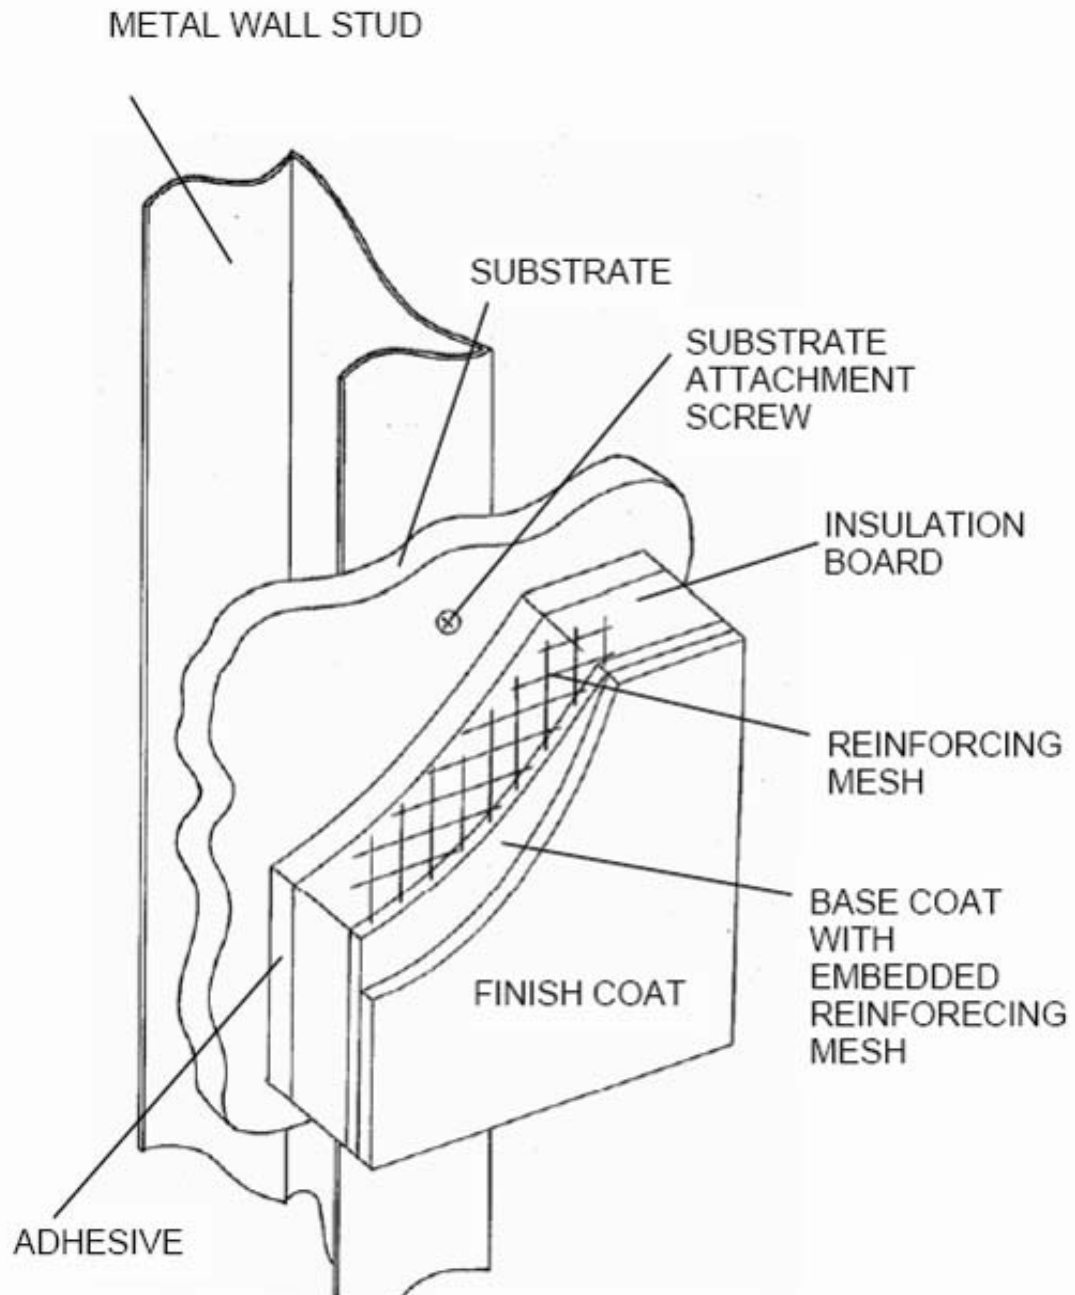
**Figure 1**  
**Configuration of an EIFS Wall Panel**  
**(FEMA, Unknown)**

The exterior of the 1997 wing is clad with an exterior foam insulating system (EFIS). EFIS, commonly known as fake stucco, “is an exterior wall cladding that utilizes rigid insulation boards on the exterior of the wall sheathing with a plaster type exterior skin” (Zwayer, 2007). “An EFIS wall typically consists of several layers of materials sandwiched together into a single panel, which is attached to a substrate mounted on the wall studs” (Figure 1) (FEMA, Unknown). In buildings constructed with a curtain wall, water is intercepted by a drainage plane once it penetrates through the brickwork; the drainage plane allows water to exit the wall system through weep holes ([Figure 2](#)). The EIFS system on the 1997 wing appears to be a *barrier* wall system. The “barrier EIFS wall systems rely primarily on the base coat portion of the exterior skin to resist water penetration” (Zwayer, 2007). In essence, the rainwater is shed by the exterior “stucco” surface, which functions as drainage plane (Figure 1). However, a number of problems exist with such a system:
